# 2012/2013 Annual Inspection Report

## VERMILION RIVER CUT-OFF BANK EROSION PROTECTION PROJECT (TV-03)

State Project Number TV-03 Priority Project List 1

April 17, 2013 Vermilion Parish

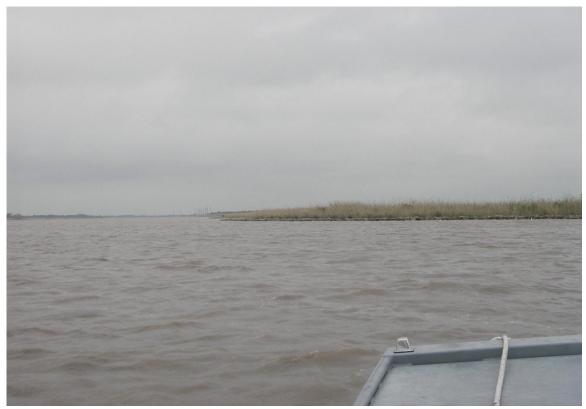
The foreshore dike is in excellent condition with no maintenance required or foreseen. A staff gauge has been installed on the northern end of the rock dike. Water level at the time of this inspection was +1.8 NAVD. (Photos, Appendix B, Photos 1-2).

**Photo No. 1**—south end of dike

| Item | Condition | Physical Damage | Corrosion | Photo # | Observations and Remarks |
|---|---|---|---|---|---|
| Rip Rap (fill) | | | | 1,2 | The foreshore dike was just recently elevated to original permitted height. |

The Vermilion River Cut-Off Project is in very good condition and functioning as designed. There is no need for any maintenance at this time.

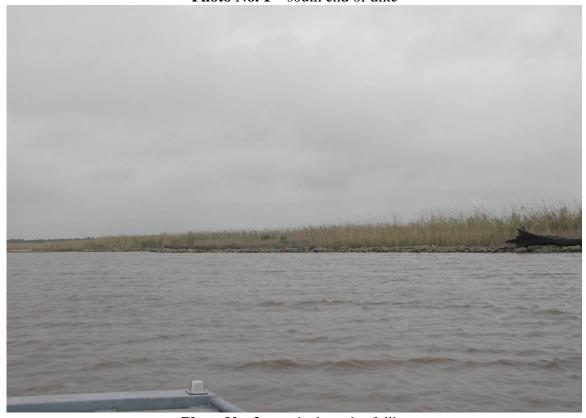
Photo No. 2—typical reach of dike
